**PHASE I  
ENVIRONMENTAL SITE ASSESSMENT**

**Former Fast Food Restaurant  
9615 Buckeye Road  
Cleveland, Ohio 44139**

**October 10, 2011**

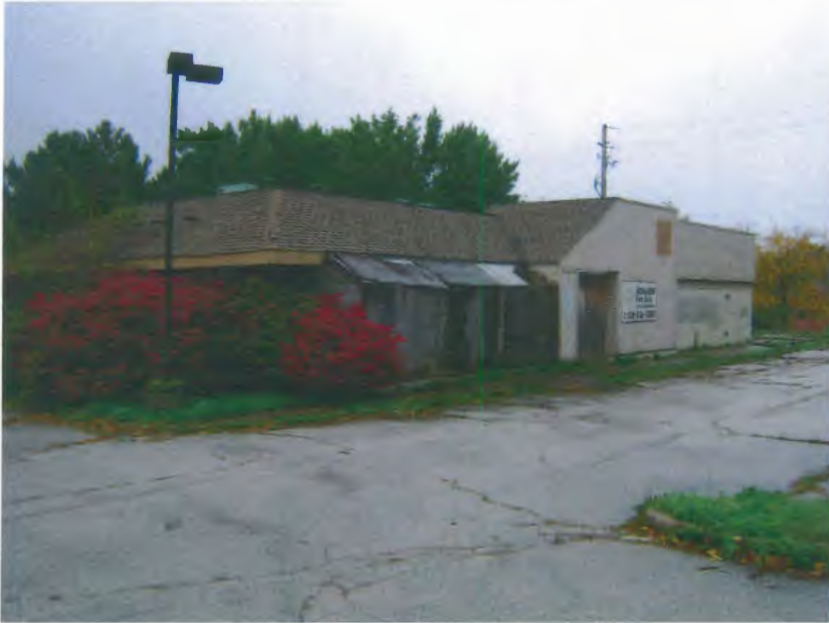
Photo 1  
View facing north of the former Burger King restaurant located on the Property.

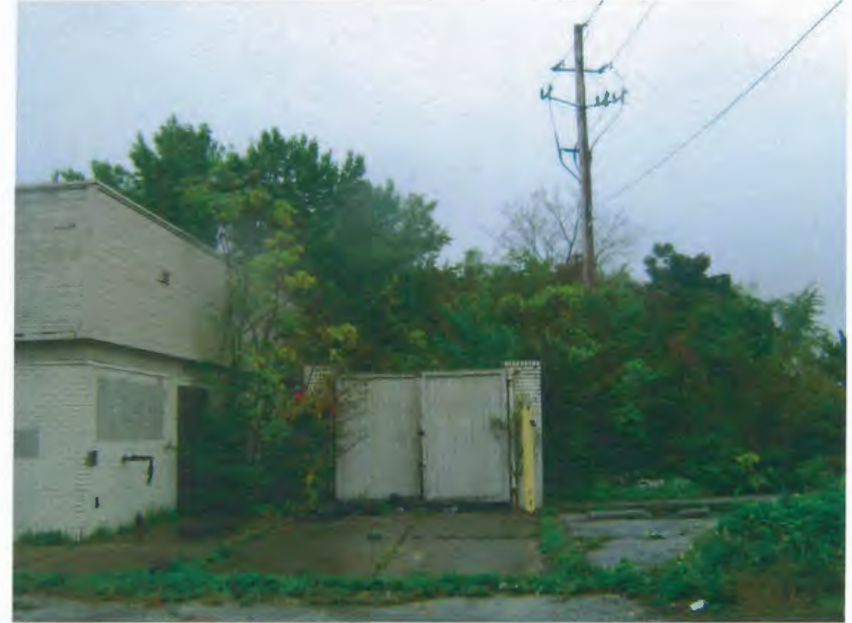
A wooden enclosure is located along the north exterior wall of the building on the Property previously housed the solid waste dumpster. A soil mound measuring approximately six (6) feet wide by three (3) feet and high covered in vegetation is present on the asphalt parking lot in the north-central portion of the Property. No surficial staining or discolorations were observed on the ground beneath the dumpster or around the soil mound. Based on the use of the dumpster and observations made during the site visit, it is unlikely that the dumpster or soil mound have adversely impacted the Property.

Photo 2  
View facing west of the former solid waste dumpster enclosure located along the north exterior wall of the building on the Property.

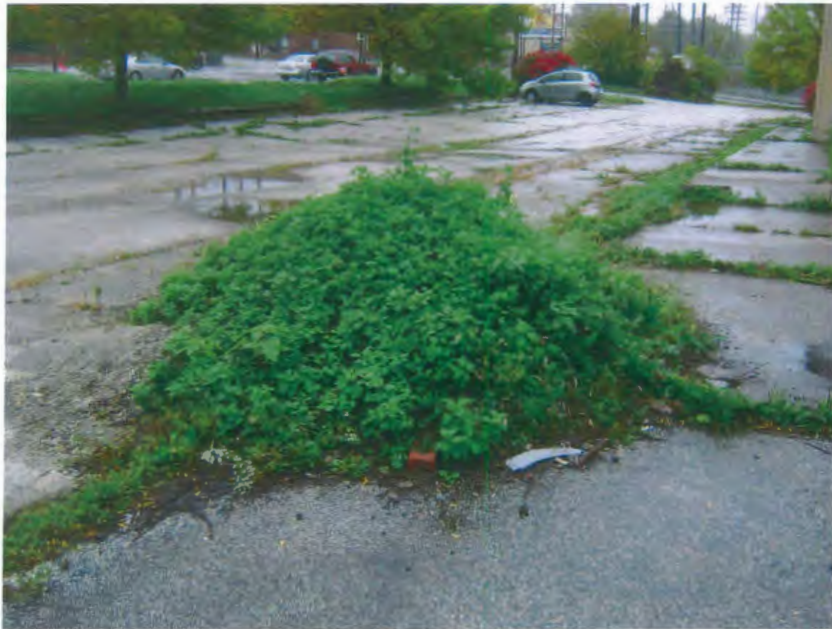
Photo 3  
View facing south of the soil mound located on the northern portion of the Property.

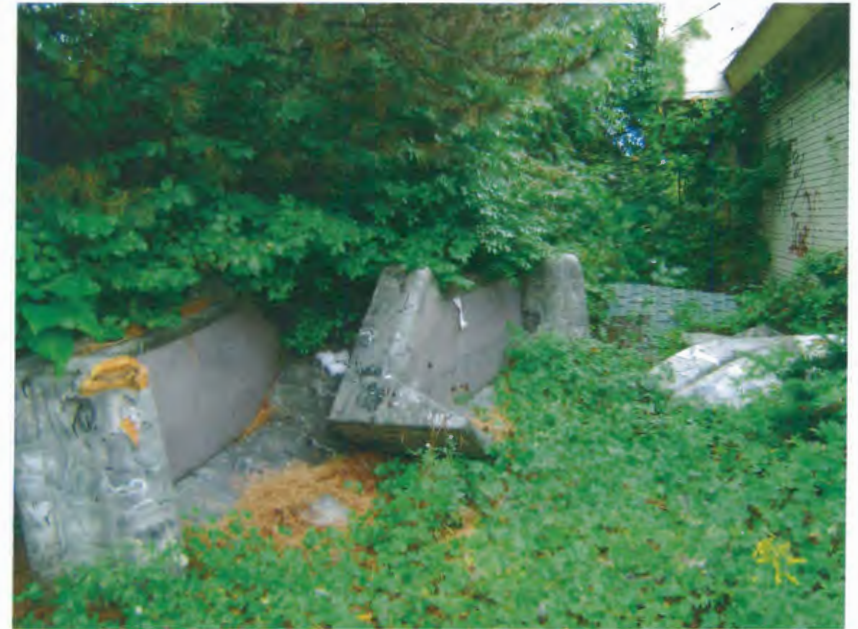
*Exterior Features:* A deteriorated drive-through lane surrounds the Former Fast Food Restaurant to the north and west. Piles of miscellaneous debris (couches, paper, bottles, etc.) and overgrown vegetation limited a visual inspection of the drive-through lane. An enclosure formerly utilized to house the solid waste dumpster extends from the north exterior wall of the building. Generally, asphalt paved parking lots are located north, east and south of the building. Trees and landscaped areas surround the perimeter of the Property. Ingress/egress to the Property is provided by access drives from Buckeye and Woodhill Roads to the south and east and Wamelink Avenue to the north. A soil mound measuring approximately six (6) feet wide by three (3) feet high and covered in vegetation is located on top of the asphalt parking lot in the north-central portion of the Property. Storm water catch basins are located in the paved parking lot.

Photo 4  
View facing northeast of the miscellaneous trash blocking the drive-thru lane along the western Property boundary.

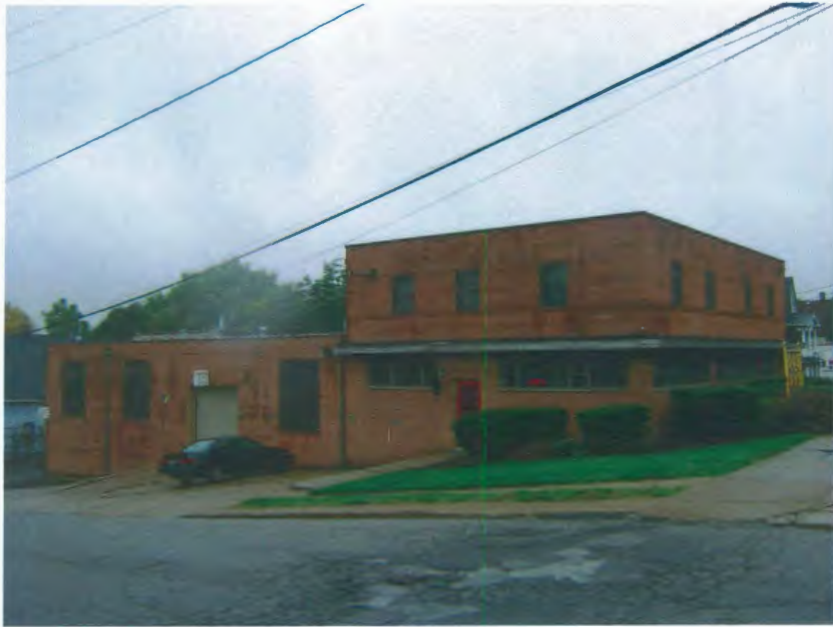
Photo 5  
View facing north of north adjoining Guardian Company Cleaning Supplies facility (2754 Woodhill Road).

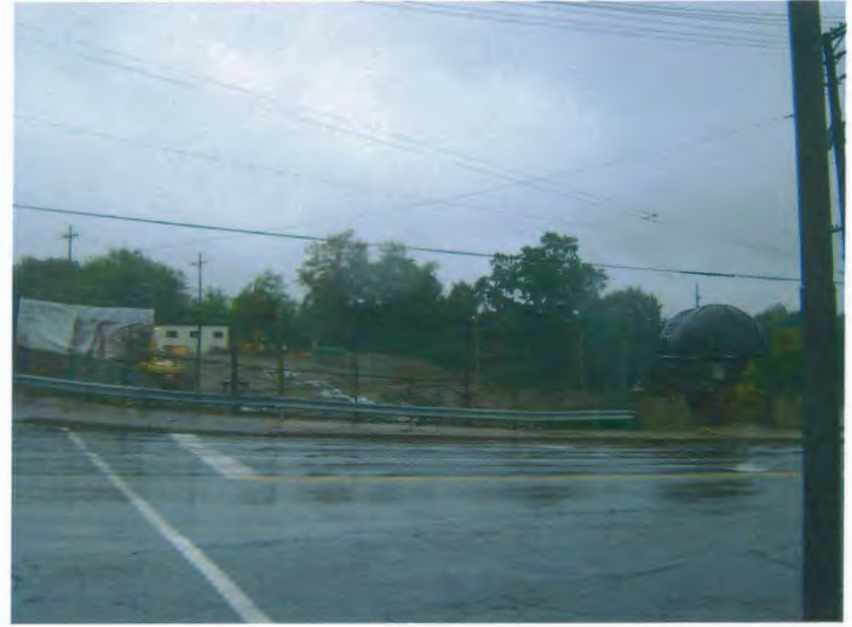
Partners observed a Transformer Substation located on the south adjoining Buckeye-Woodhill RTA Blue/Green Line Substation.

Photo 6  
View facing southwest of the south adjoining Buckeye-Woodhill RTA Substation that is currently under construction.

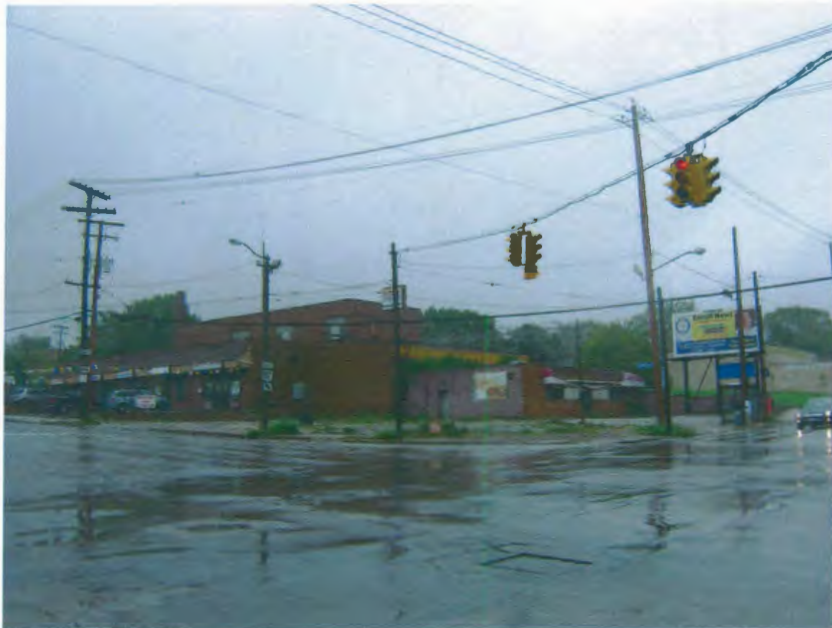
Partners observed a concrete pad in the same configuration as a former gasoline filling station located approximately 125 feet south of the Property (2795-2801 Woodhill Road). Refer to **Section 9.0** for additional information.

Photo 7  
View facing southeast of the south adjoining former gasoline filling station (2795-2797 Woodhill Road) and multi-tenant commercial building (9718 Buckeye Road).

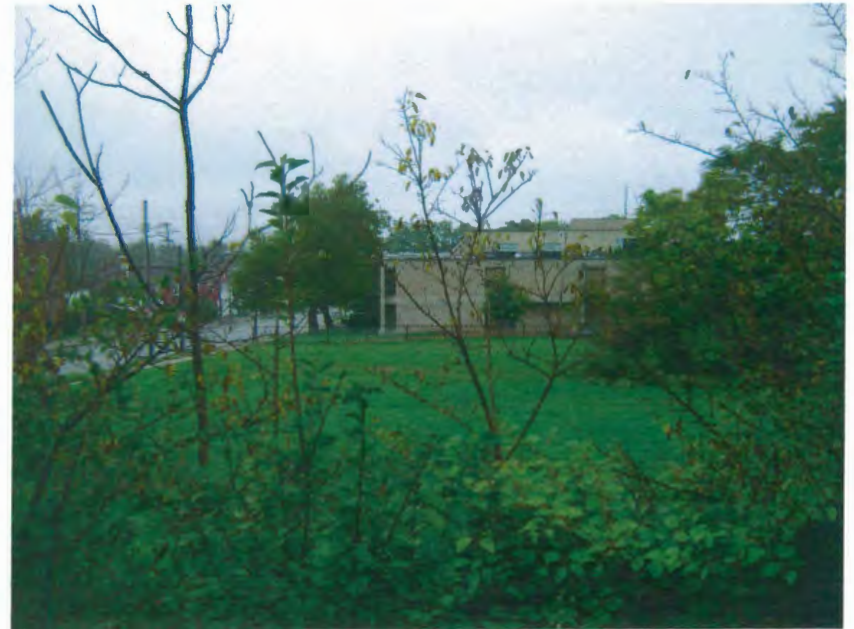
Photo 8  
View facing northwest of the west adjoining vacant grass lots and the Buckeye-Woodland Elementary School (9511 Buckeye Road).

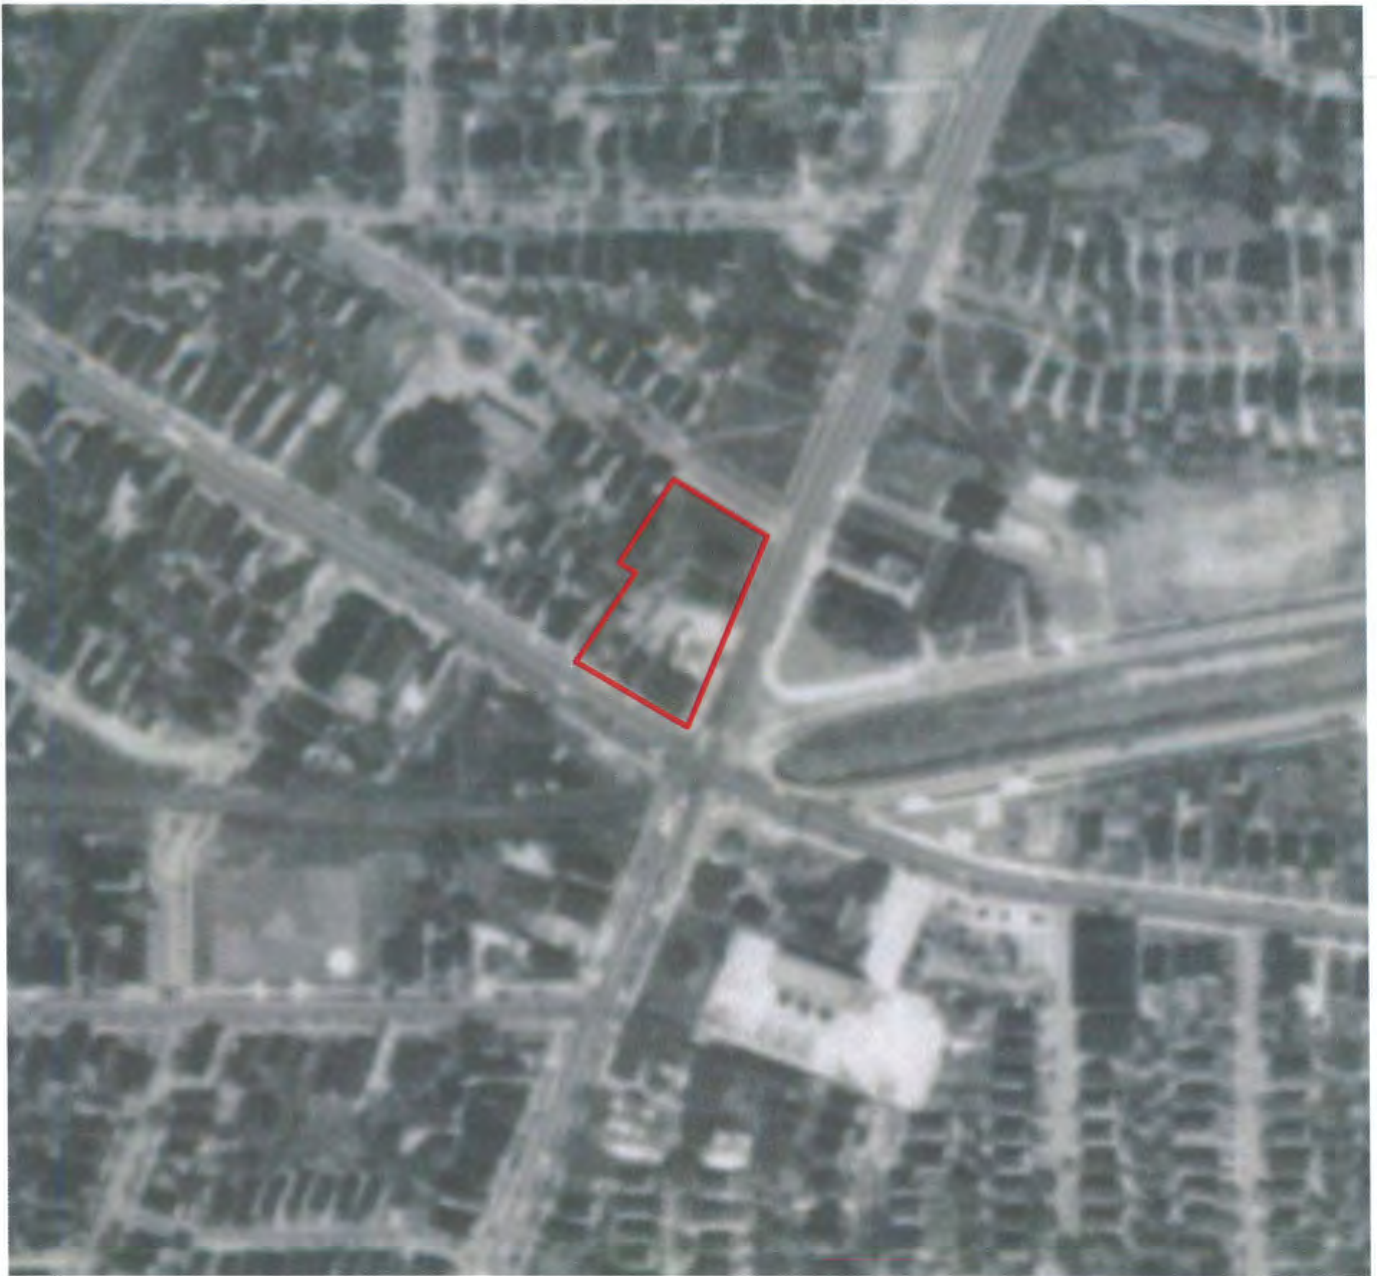
**1951 - Aerial Photograph**

**1951:** The Property and surrounding area is developed; however, the poor resolution of the aerial photograph makes it difficult to discern structures. The Property appears to be developed with residential structures on the northern and southwestern portions, a storefront on the southeast corner and a rectangular structure surrounded by a paved parking area on the south-central portion. This structure is in the same configuration as an auto repair facility and gasoline filling station shown in Sanborn Fire Insurance (Sanborn) maps.
